**MISSAN SURGICAL HOSPITAL**  
**UNDER THE ECONOMIC SUPPORT FUND**  
**AL AMARAH, IRAQ**

**SIGIR PA-08-165**  
**SIGIR PA-08-167**

**JULY 16, 2009**

## Summary of Report: PA-08-165 and PA-08-167

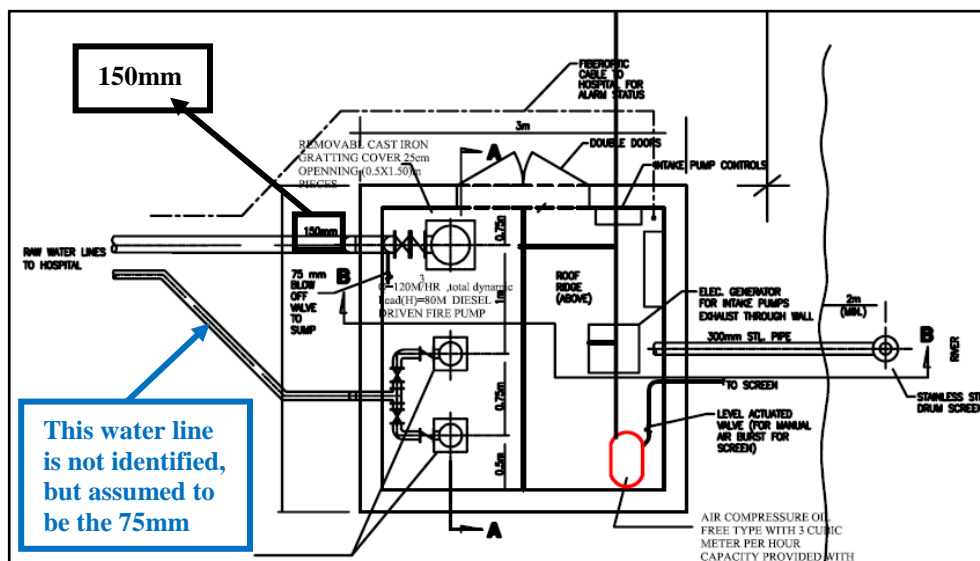
Figure 10. Contractor’s river intake detail design (Courtesy of GRS)

In addition, GRS provided two designs drawings for the raw water intake; both designs dated 30 April 2008. These designs, dated 8 months prior to SIGIR’s site visit, were not part of the original project file documentation provided to SIGIR; instead GRS provided these drawings after the exit conference. After reviewing both designs, SIGIR determined them to be, at best, conceptual designs because they lacked specific details on piping elevations and lengths, electrical systems designs, access roads, flooding levels, and grading requirements.

Further, when placed together, the two designs clearly show a lack of detail and cohesion. For example, the SOW required two water lines – one for water processing and one for fire suppression. The “River Intake 6-5 River Intake (1)” design identified only the 150 mm water line; while the “site-maissan Water(27) WATER FIRE(27)(1)” design only identified the 75 mm water line (Figures 10-12). Also, since the security wall has already been constructed, the contractor will now have to excavate under it in order to route the water lines under the wall. In addition, the exact location of the river intake has yet to be determined; instead GRS AAO stated it will be “located approximately where the Tigris [River] and Al Kahla [River] intersect.”

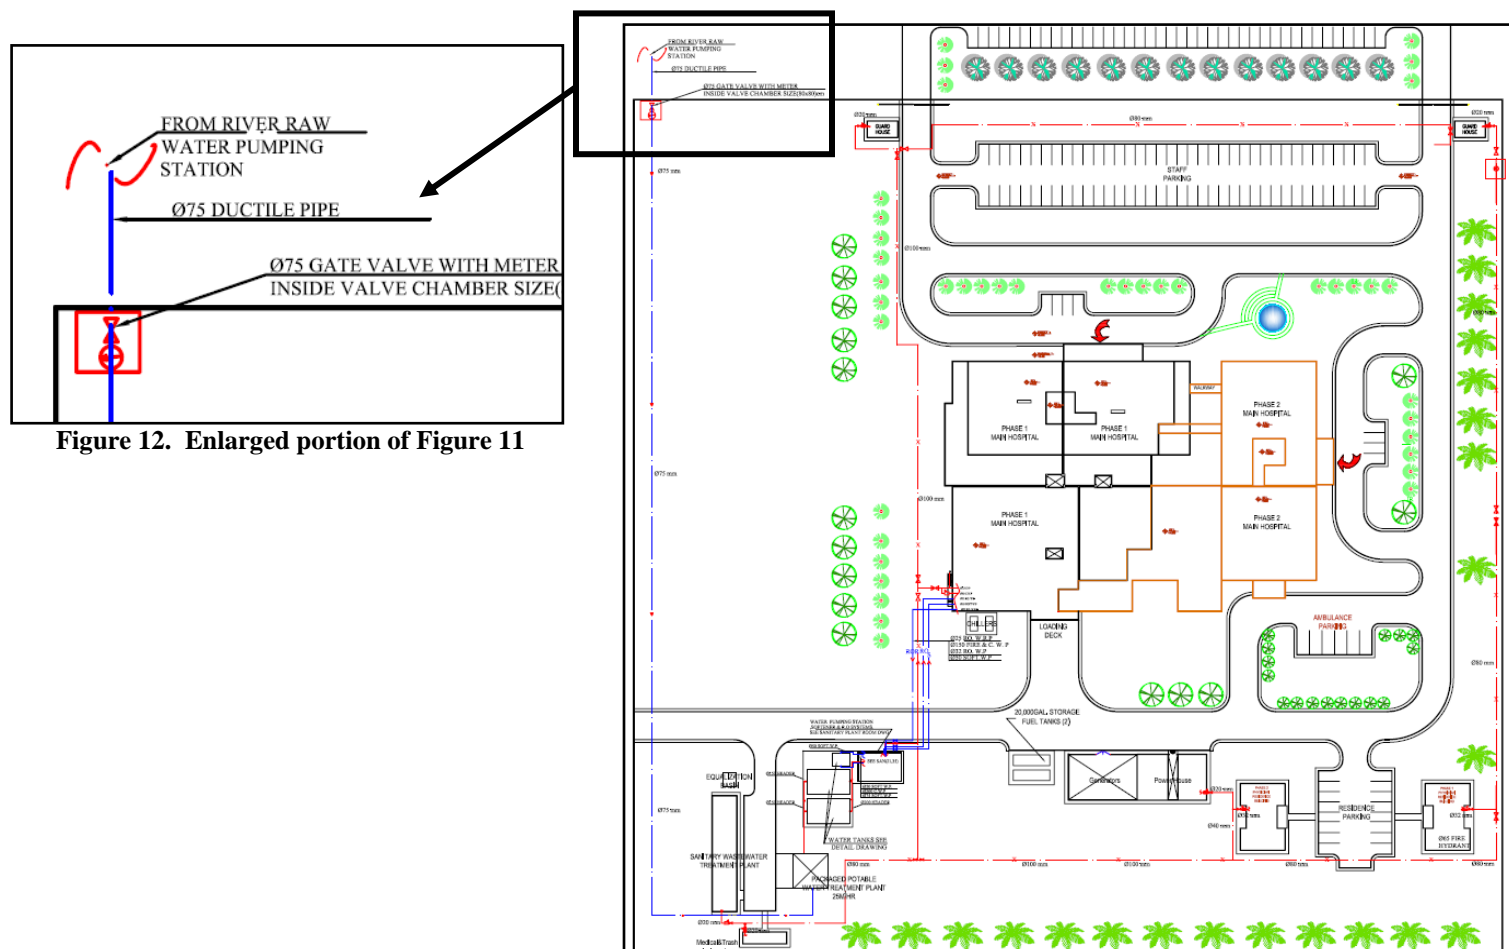
Figure 11. Contractor's water site plan (Courtesy of GRS)

Figure 12. Enlarged portion of Figure 11

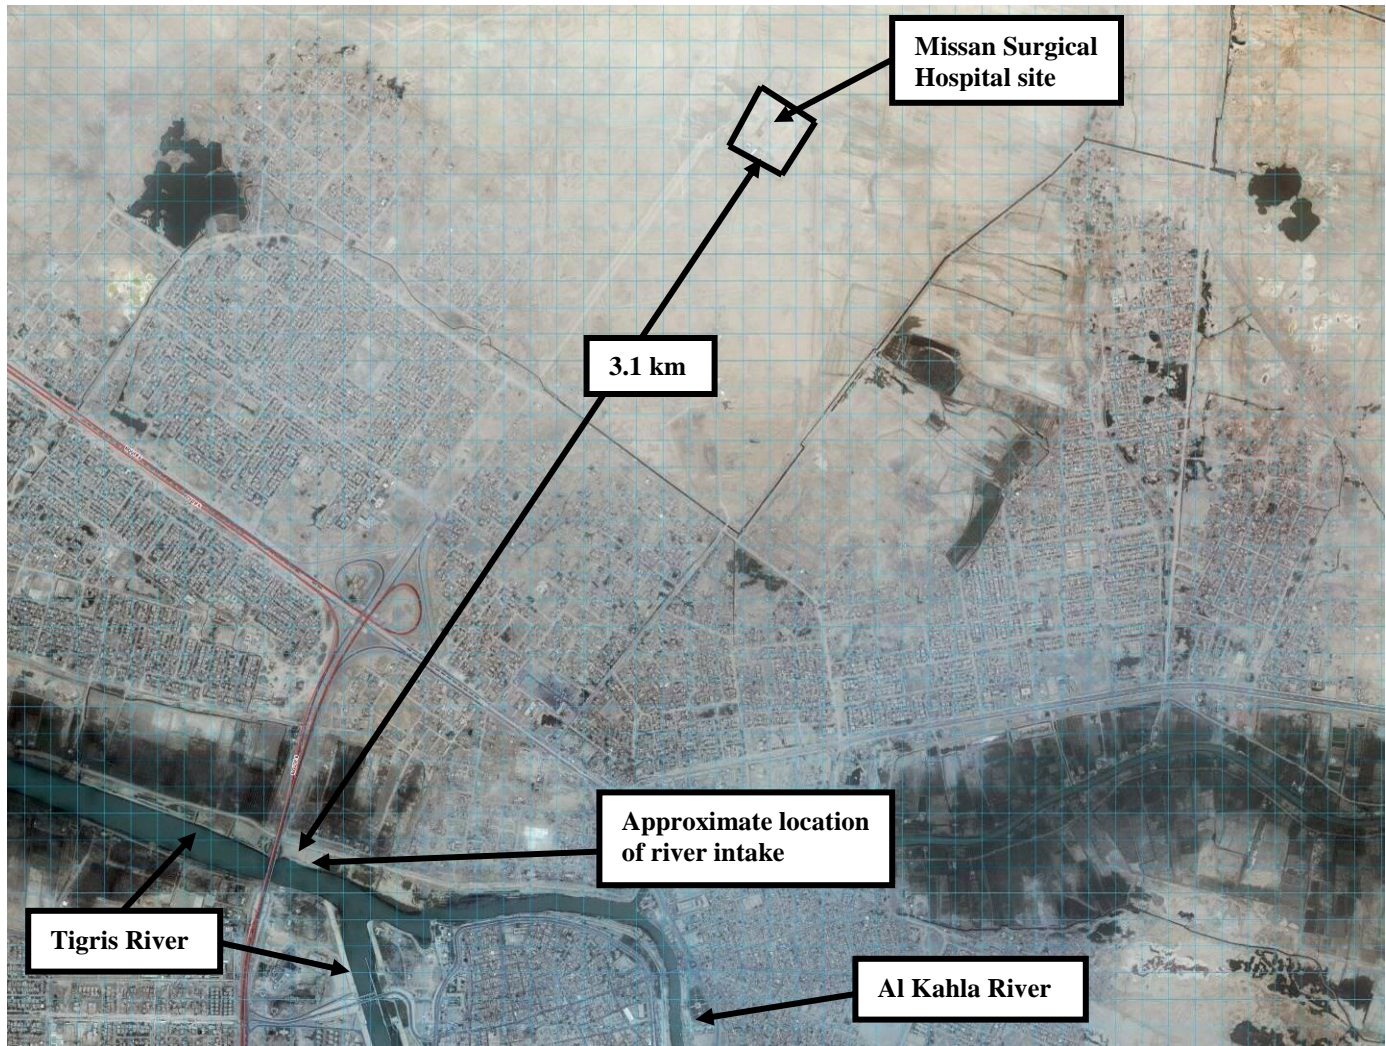
**Figure 13. Aerial view of the water lines to be run from the river intake to the hospital site  
(Courtesy of the National Geospatial-Intelligence Agency)**

Of particular concern to SIGIR is the lack of the defined route from the river intake to the hospital. According to GRS, the current plan is to place the river intake near the intersection of the Tigris and Al Kahla Rivers and then run the water lines to the hospital site. However, this would require the contractor to excavate and lay two pipe lines a total of 3.1 km through a significant portion of the city of Al Amarah (Figure 13). In a previous SIGIR Inspections report of the Falluja Wastewater Treatment Plant, SIGIR documented significant delays and serious security issues due to the fact the contractor had to excavate and lay pipe through the city.

According to GRS AAO representatives, the contractor is currently “working with the municipality for routing the water lines.” However, SIGIR believes that the planning for the identification of the water source, location of the river intake, and routing of the water pipe lines to the project site needed to be done at the onset of the project, not 20 months after the NTP was issued. GRS, the contractor, and the municipality should have discussed the various options for the water supply at the beginning of the project. The delay in addressing this issue has resulted in the contractor and municipality having to determine the least intrusive method to install below ground water lines. As was learned from the Falluja Wastewater Treatment Plant inspection, excavating through a city is challenging and could be slow and dangerous work for the contractor.

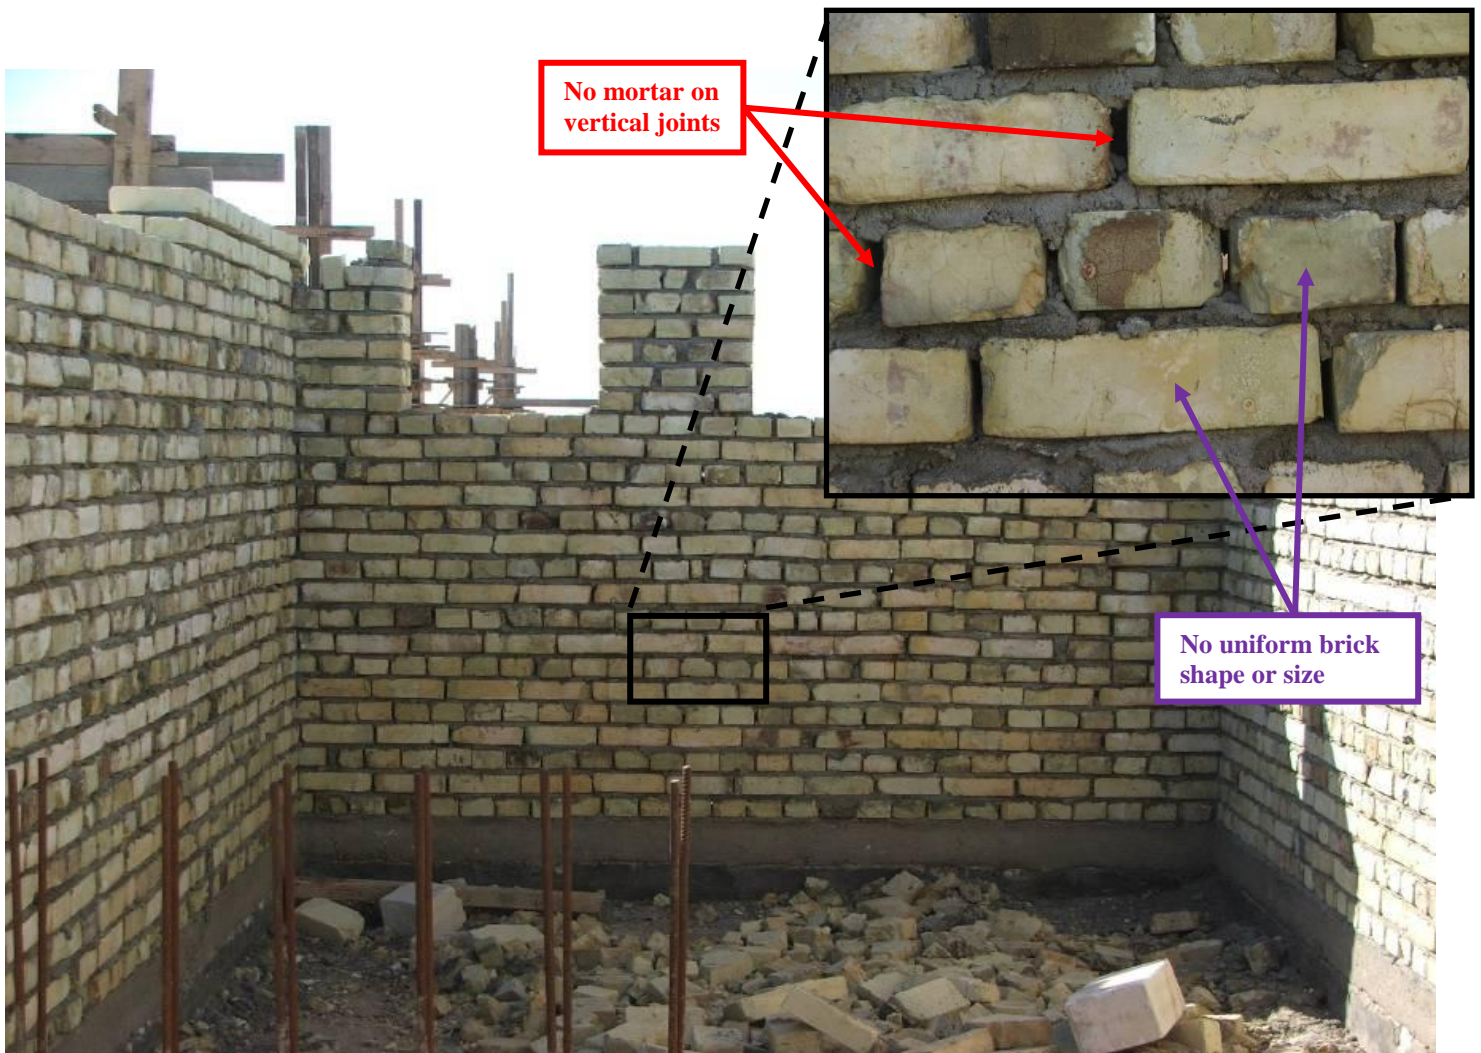
The construction of the brick walls followed local construction techniques and is a two "Wythe English" bond configuration. The bricks are not mortared on perpendicular (vertical sides) nor are they uniform in shape or size (Site Photo 18). While the methods and quality of construction is not comparable to typical European brick masonry, the small size and limited number of stories of this structure should result in relatively low stresses in the brick.

Site Photo 18. Physicians' residence (typical example of brick construction)
